**REPORT OF INITIAL STUDY OF
ALTERNATIVES
OLD MILL POND DAM
STATE ID NO. 105.03
HAMPTON, NEW HAMPSHIRE**
SA Project No. 111-12-002
October 11, 2013

**Re: Report of Initial Study of Alternatives
Old Mill Pond Dam, State ID No. 105.03
Hampton, New Hampshire**

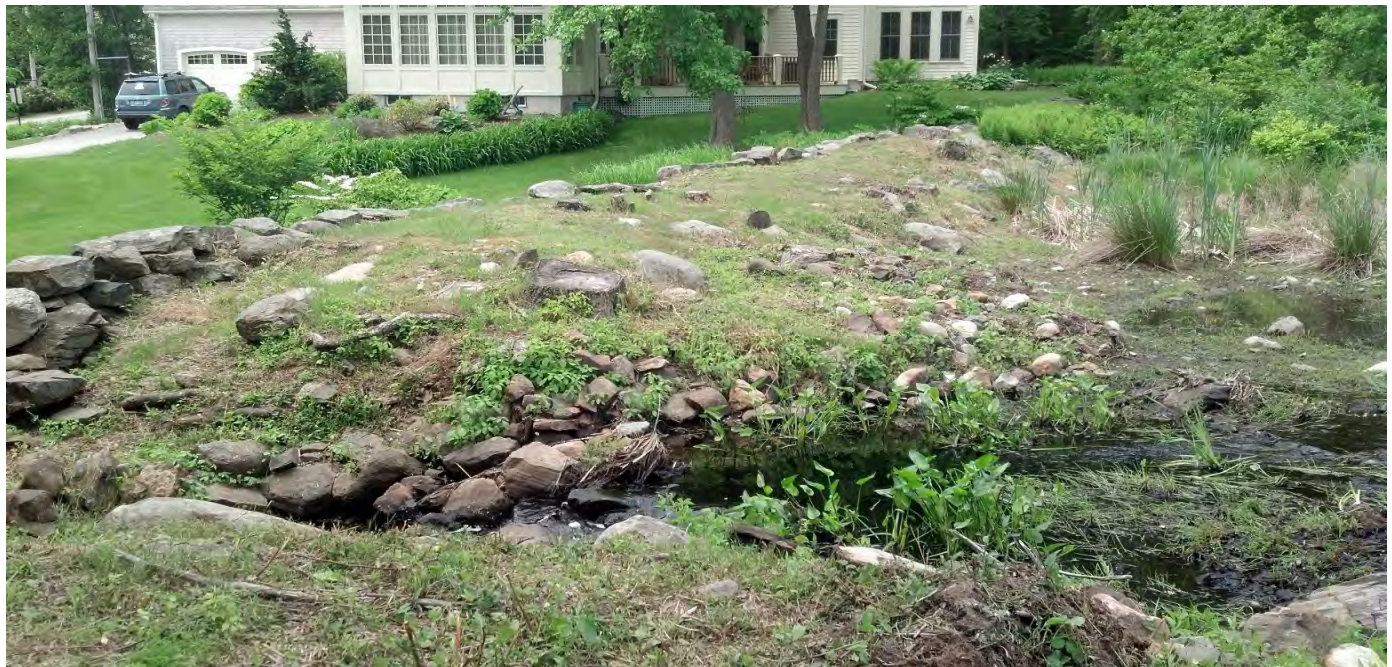
Photo Number: 2
 Description: Right embankment and spillway viewed from left embankment

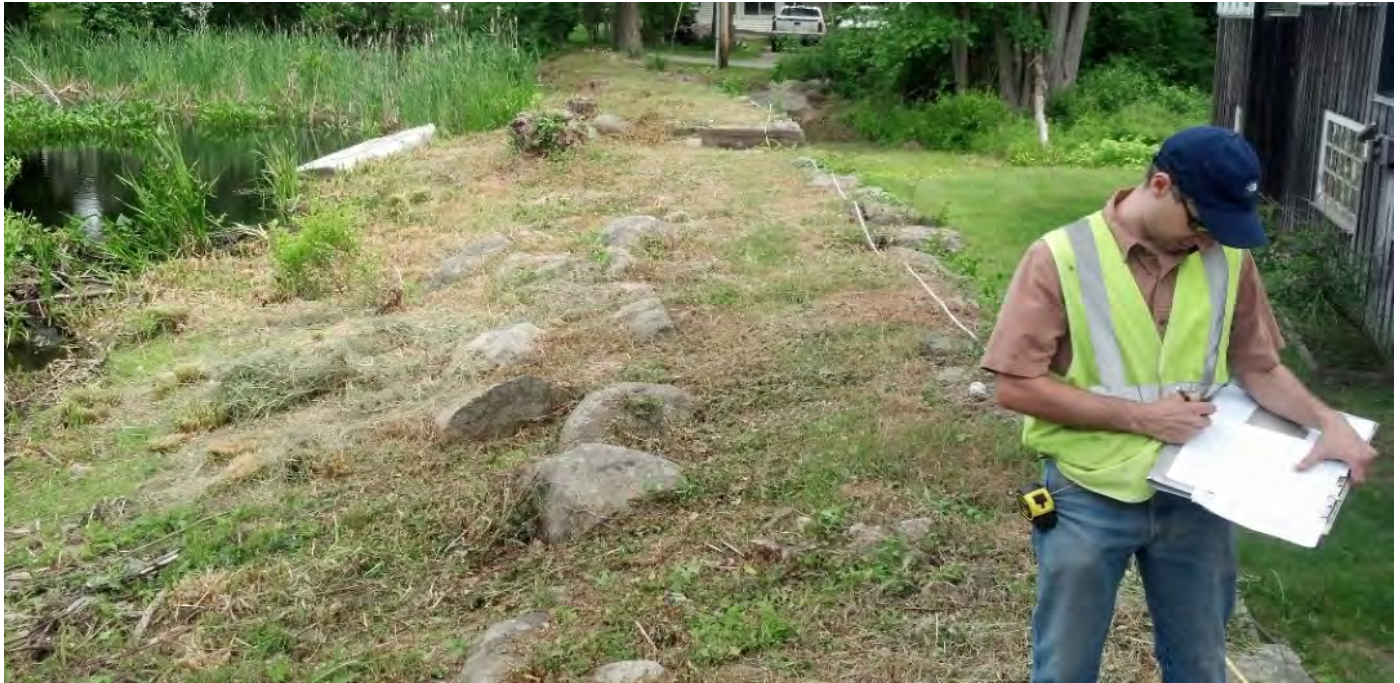
Photo Number: 5
Description: Left embankment and Spillway

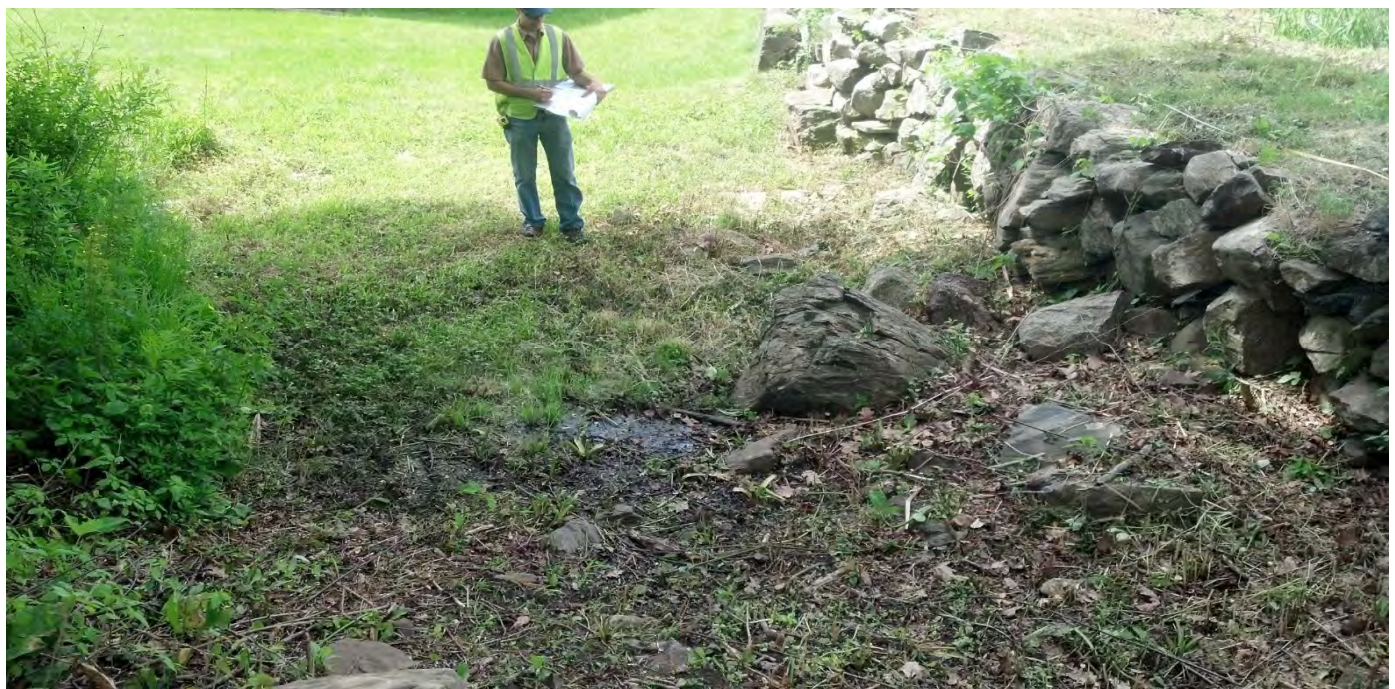
Photo Number: 7
Description: Wet area downstream of left embankment

SA visually inspected the Dam on June 6, 2013. The Inspection Checklist attached in Appendix A describes our observations in detail. The deficiencies noted below will need to be addressed if the Dam is repaired to remain in service. Based on our visual inspection, we noted the following issues:

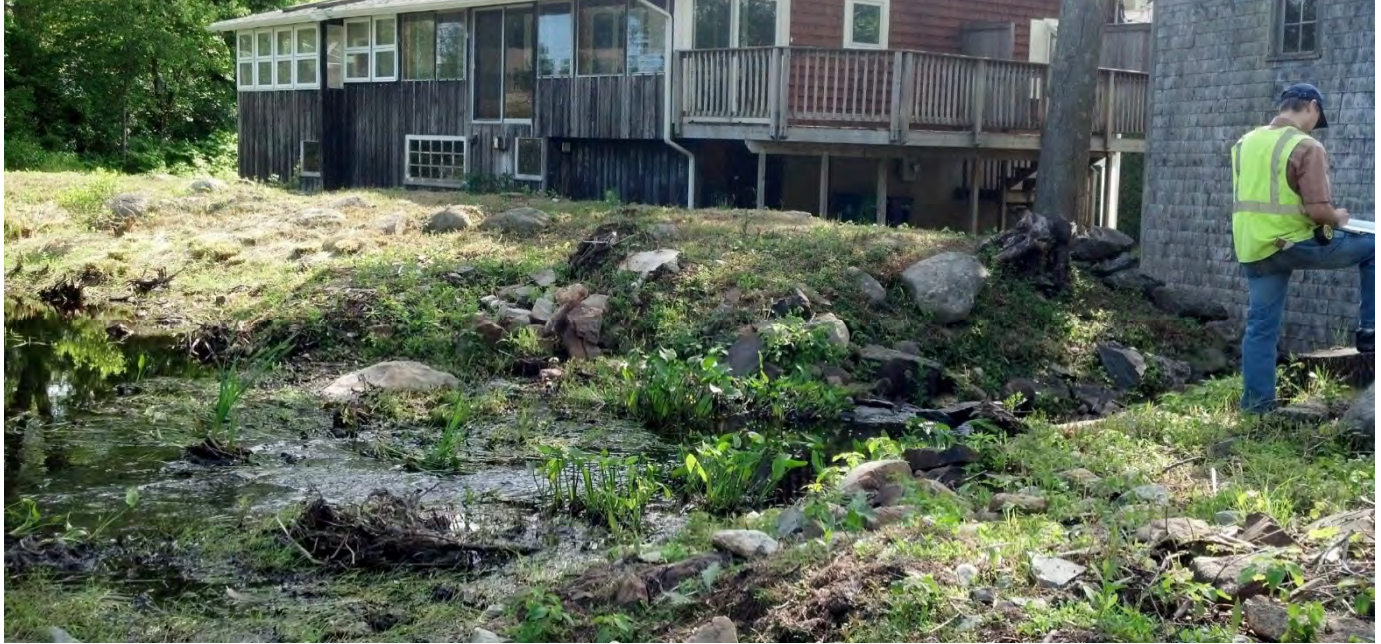
Photo Number: 8
 Description: Spillway and right end of left embankment

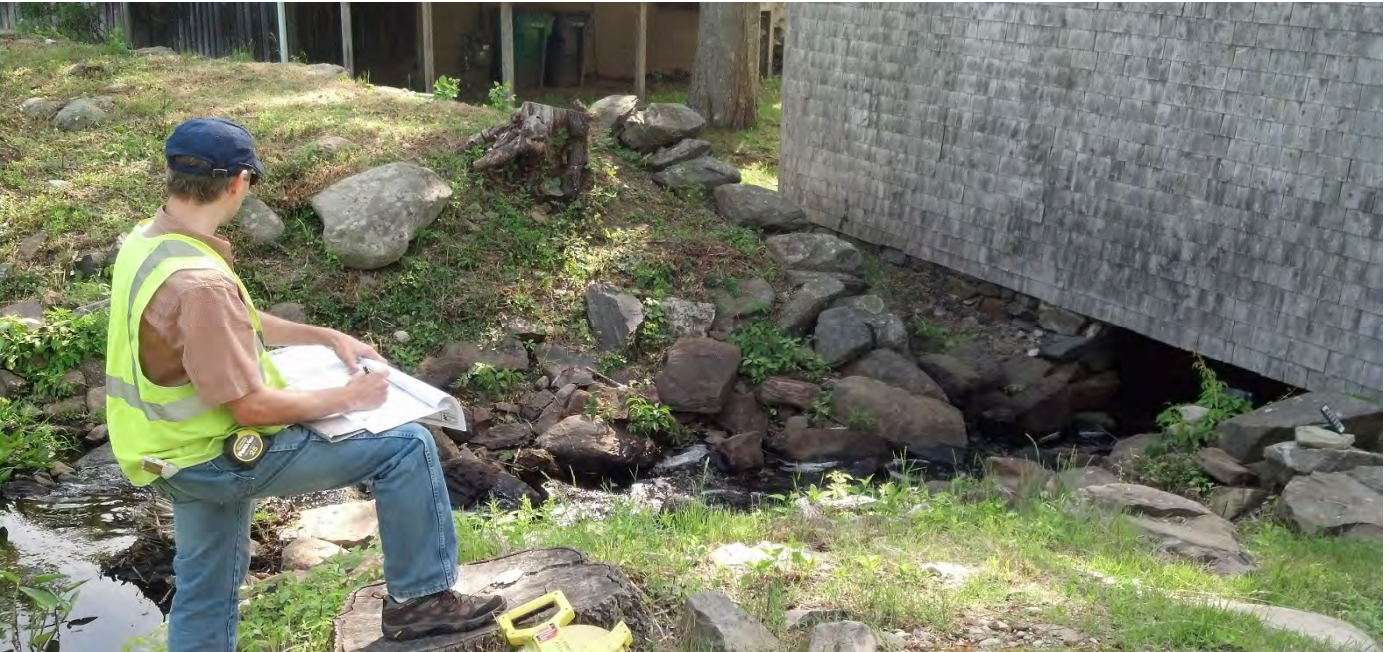
Photo Number: 9
 Description: Spillway and right end of left embankment

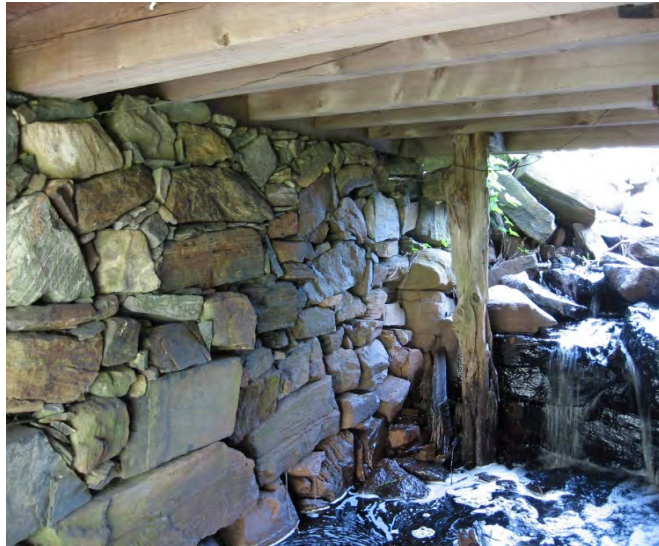
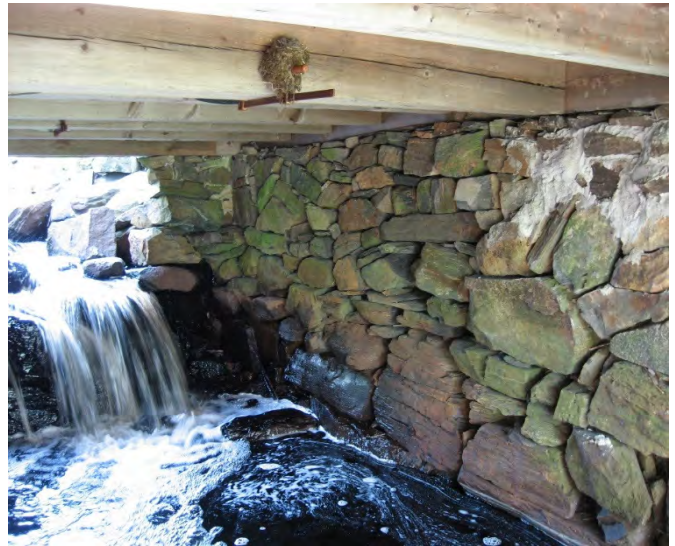
Photo Number: 11
 Description: Spillway channel under mill looking left and right

Both alternatives of Dam repair and decommissioning will reduce risks to the Mill. We estimate the opening under the Mill is about 5.9 ft. tall with hydraulic capacity of about 364 cfs. The concepts of Dam repairs include replacing the spillway such that the 100-year flood passes through the Mill opening, rather than flowing around the Mill.

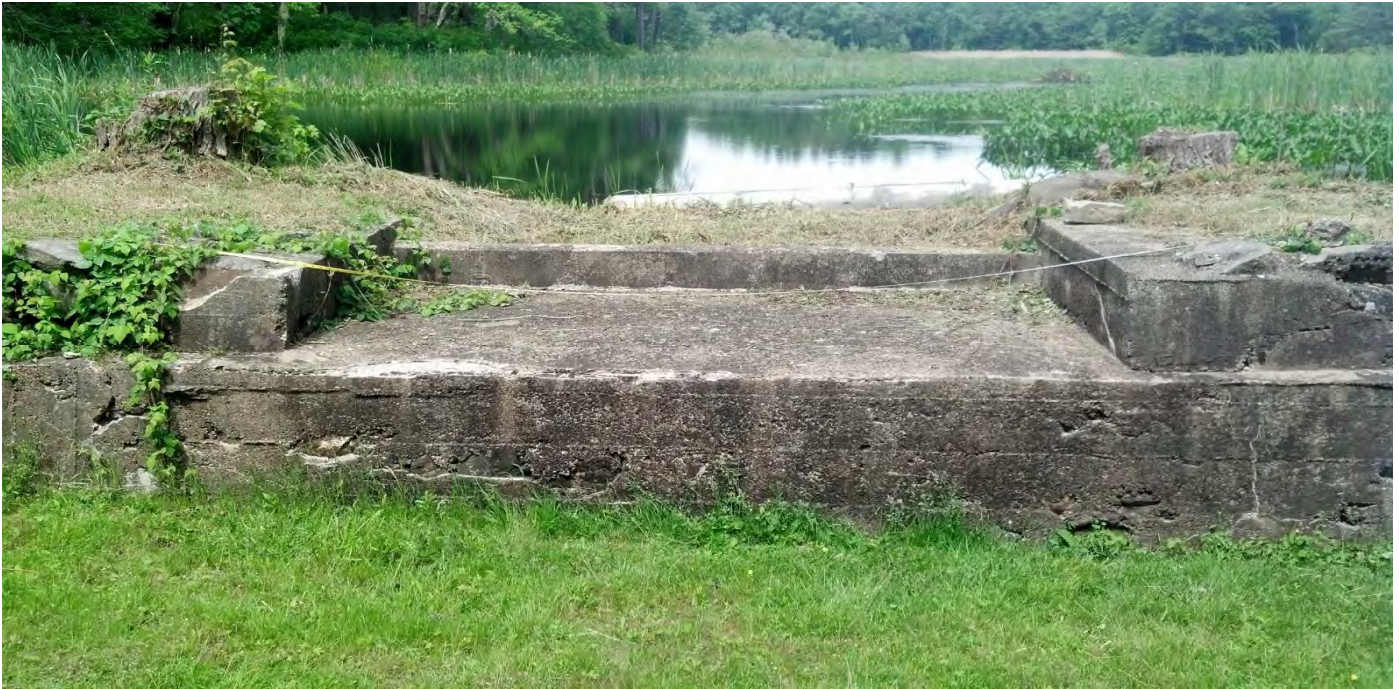
Photo Number: 13
Description: Auxiliary Spillway

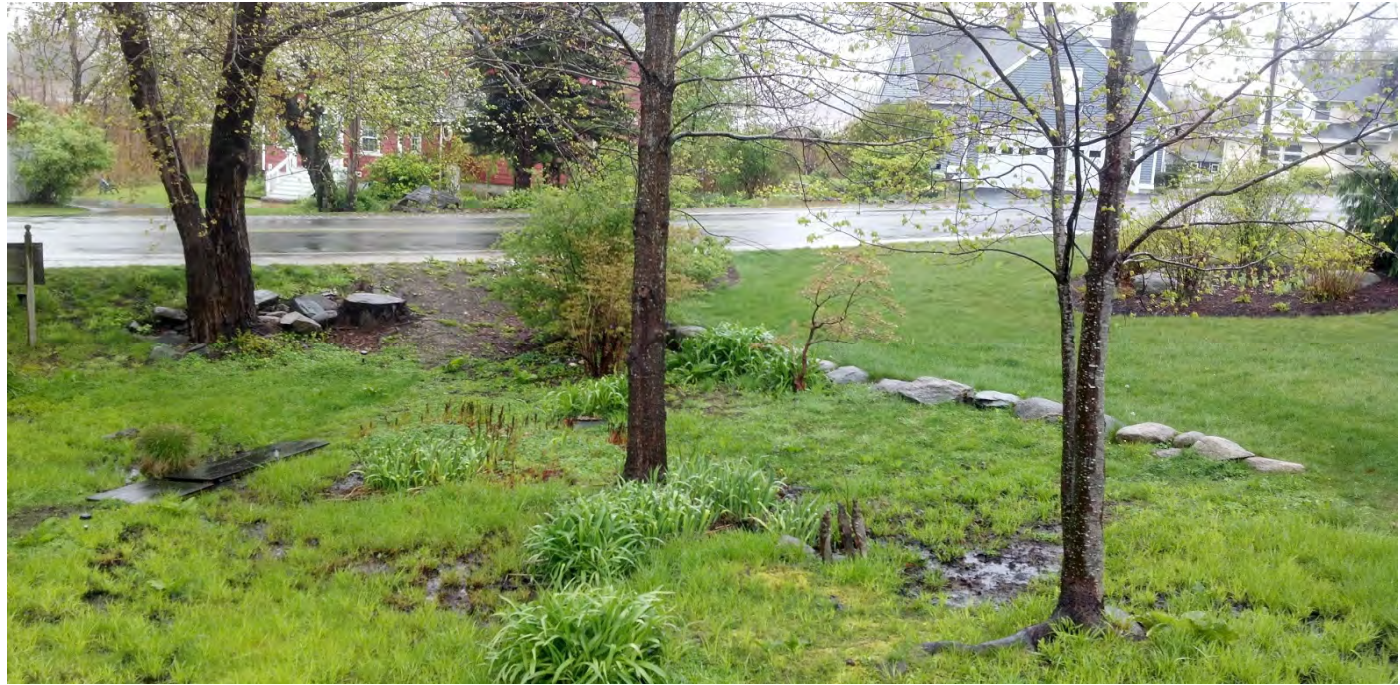
Photo Number: 15
 Description: Downstream area right of channel showing wet areas

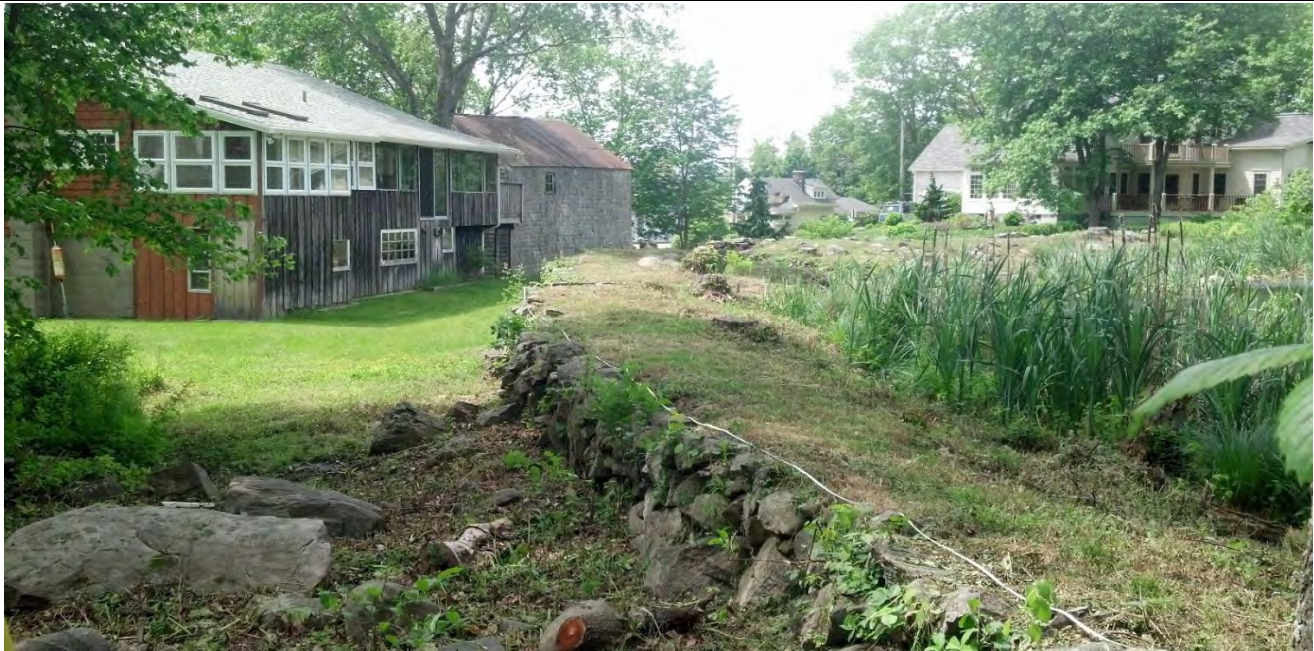
Photo Number: <u>1</u>	Dam left (looking downstream) embankment viewed from near left end. No. 490 High St. in foreground; Old Grist Mill 488-A High Street in middle; No. 488 High St. photo right/background.
Description:	
Photo Date: <u>June 6, 2013</u>

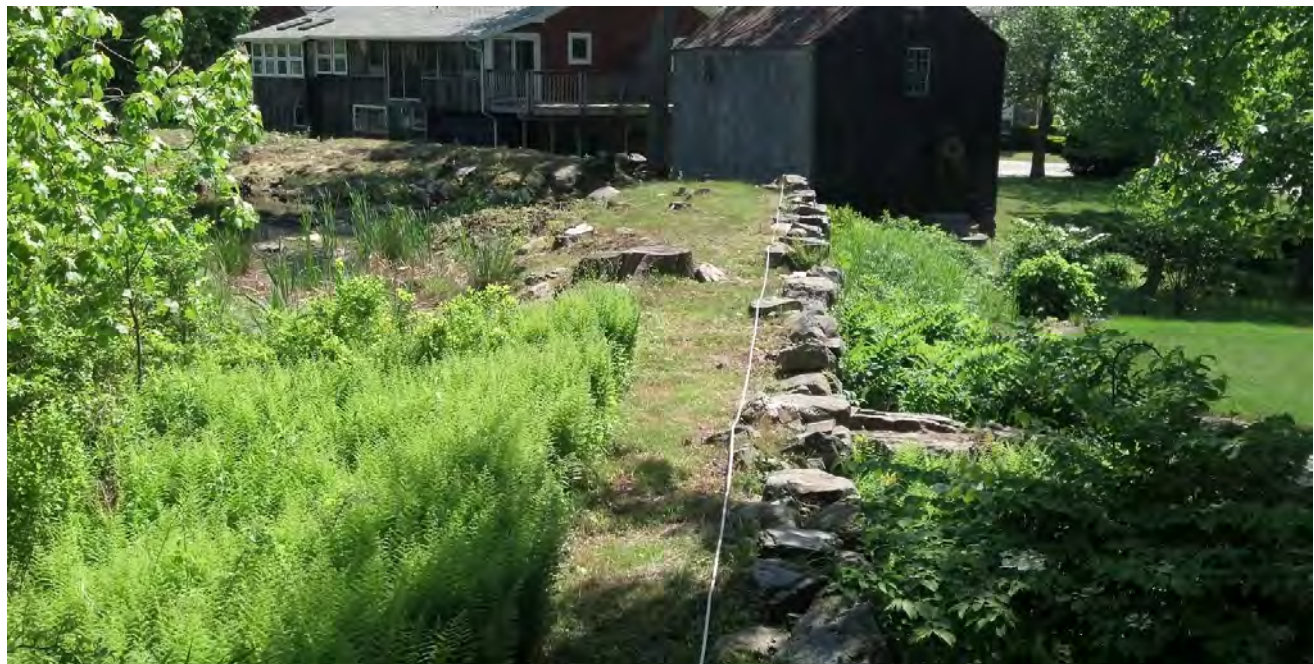
Photo Number: <u>2</u>	Dam right (looking downstream) embankment viewed from near right end. Old Grist Mill in middle; No. 490 High St. to photo left.
Description:	
Photo Date: <u>June 6, 2013</u>
